# 2B+G+7 RESIDENTIAL BUILDING DOHA, QATAR

**CCL Client:** Al Badia Trading and Contracting Est.

**Consultant:** Fain Design

Repair and Strengthening - CCL Qatar

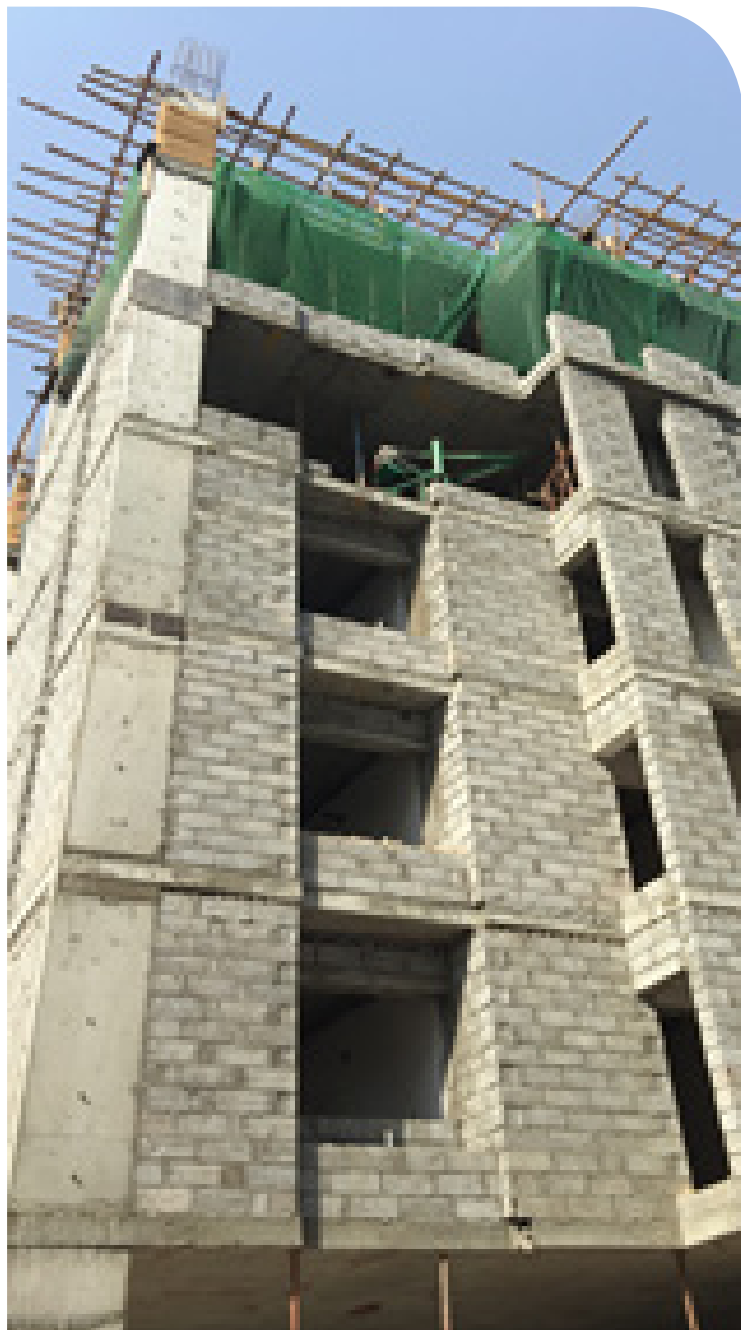
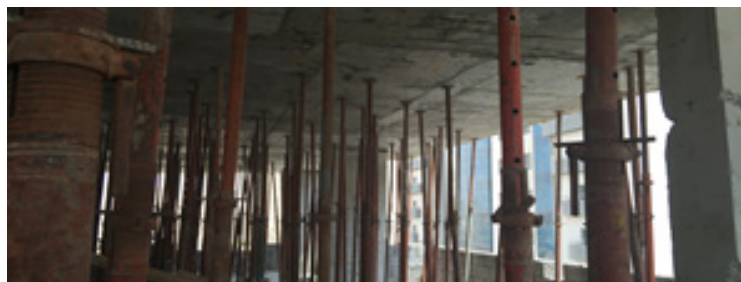
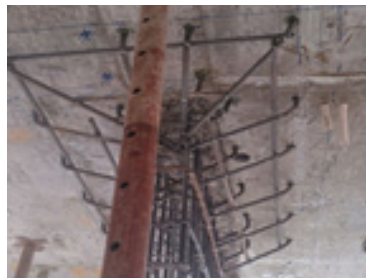
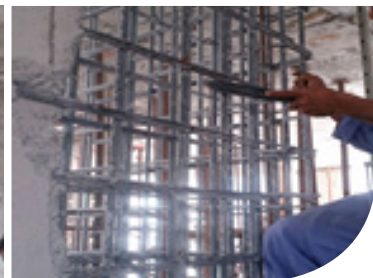
Though CCL was not part of the original construction team, their expertise was sought as testing at 28 days raised concern over the compressive strength of the concrete in the columns and core walls at level five of the building.

Back propping of slabs took place on levels five and six, and column replacement was done in stages, to take into account load transfer on all props and beams throughout this process. Strengthening of the core walls was successfully completed through the addition of reinforced concrete columns.

CCL proposed introducing additional drop caps to columns in order to protect against punching shear. As recommended by CCL, carbon-fibre-reinforced polymer was installed in a number of locations. High-strength, non-shrink concrete was used to create all the vertical elements during works.
