# DRONFIELD SEWAGE TANKS DRONFIELD, UK

**CCL Client:** Yorkshire Water

**Project Date:** September 2011

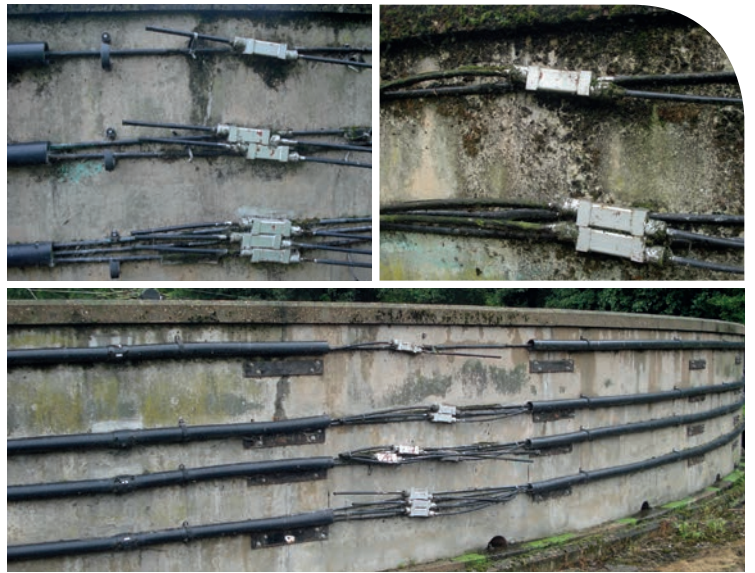
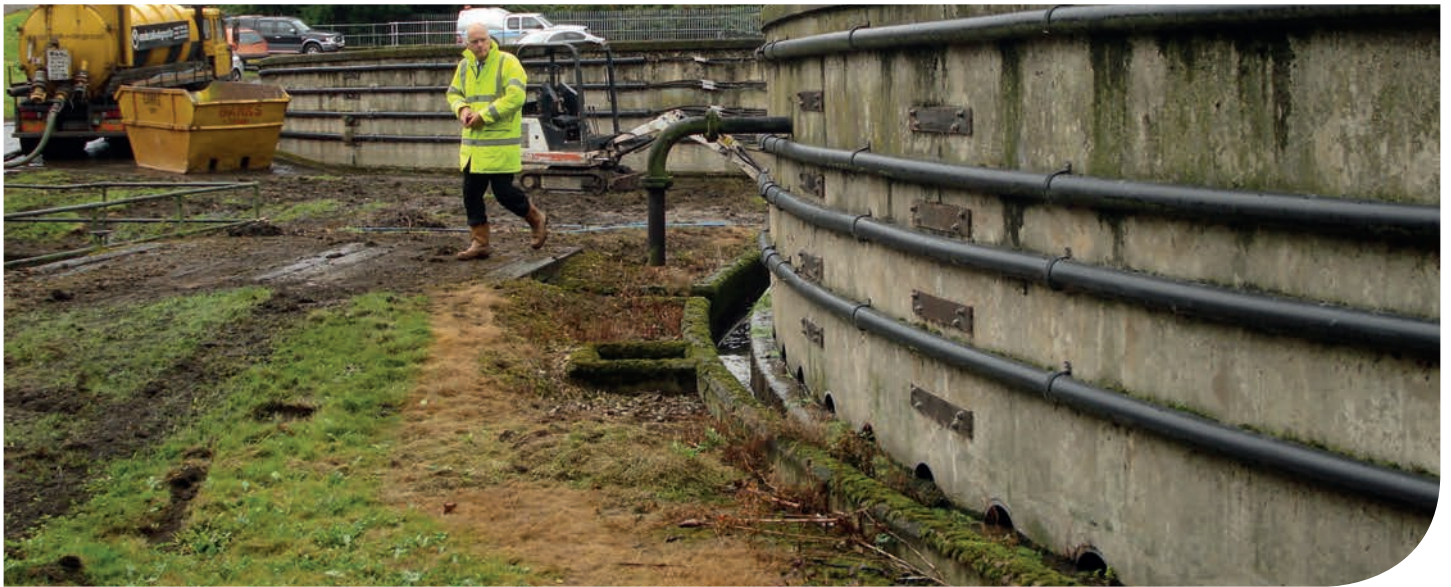
Six cylindrical concrete sewage tanks located in Dronfield, near Sheffield, required inspection in order to assess their structural condition. The tanks were constructed during the 1970s, and were beginning to exhibit signs of age.

In particular, the external post-tensioning was showing signs of relaxation. CCL was called in to investigate and provide an assessment of any necessary remedial action.

This involved load checking the unbonded monostrand post-tensioned tendons to assess residual loads. Using a monostrand jack, a lift-off test was carried out to monitor wedge release and determine the load in each tendon.
